September 8, 2010: Gordon Stansberry Well Site and Pipeline - Photograph Log

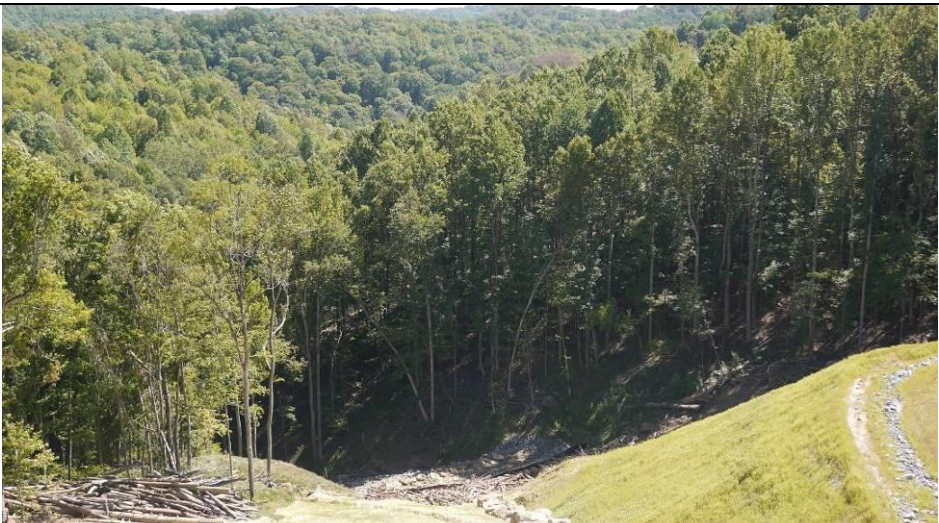
Photo ID: P1030233.JPG
	Date: 9/8/2010
	Description: Middle of slope/valley fill

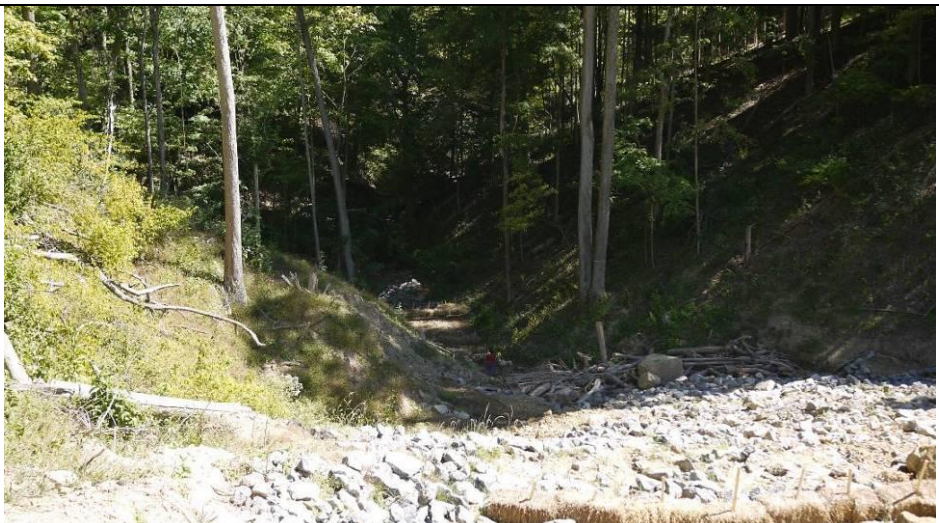
Photo ID: P1030235.JPG
	Date: 9/8/2010
	Description: Bottom of slope/valley fill

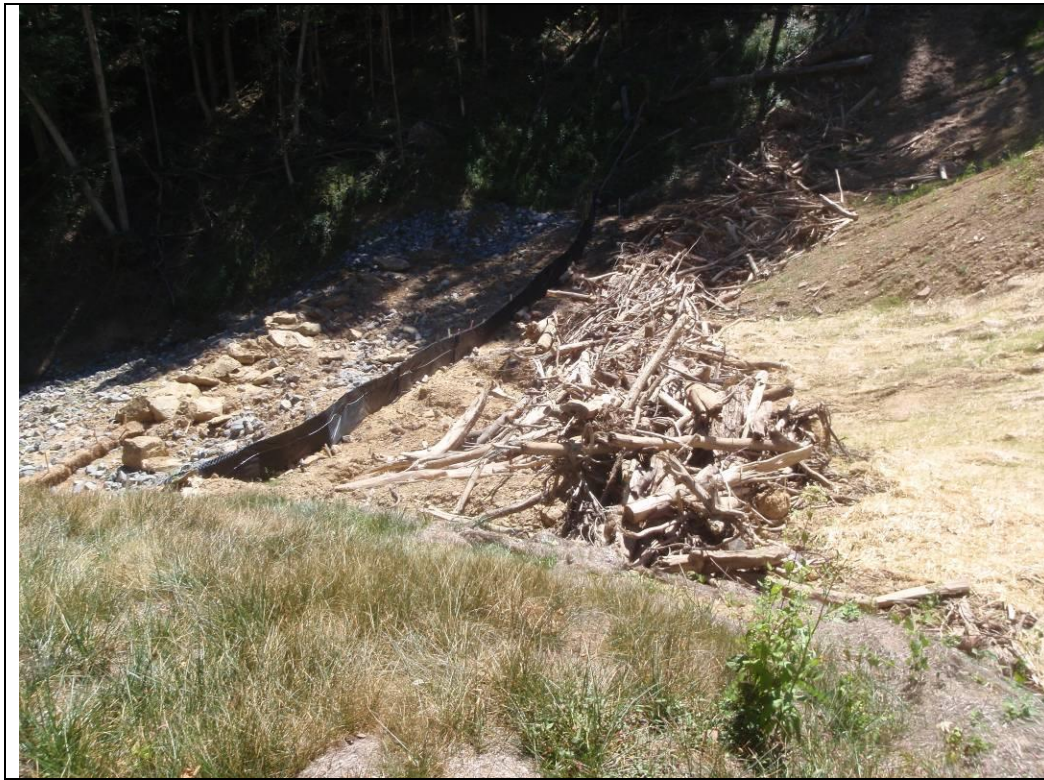
P9080201.JPG

Photo of fill above
toe of slope

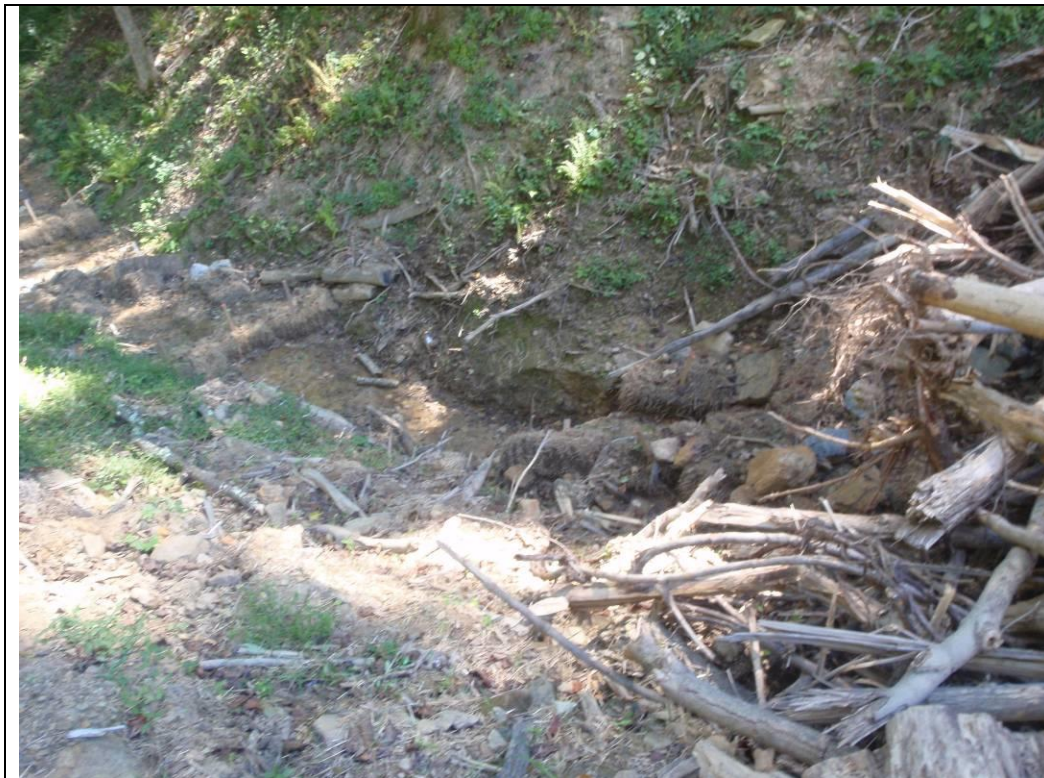
P9080204.JPG

Toe of slope; stream
fill

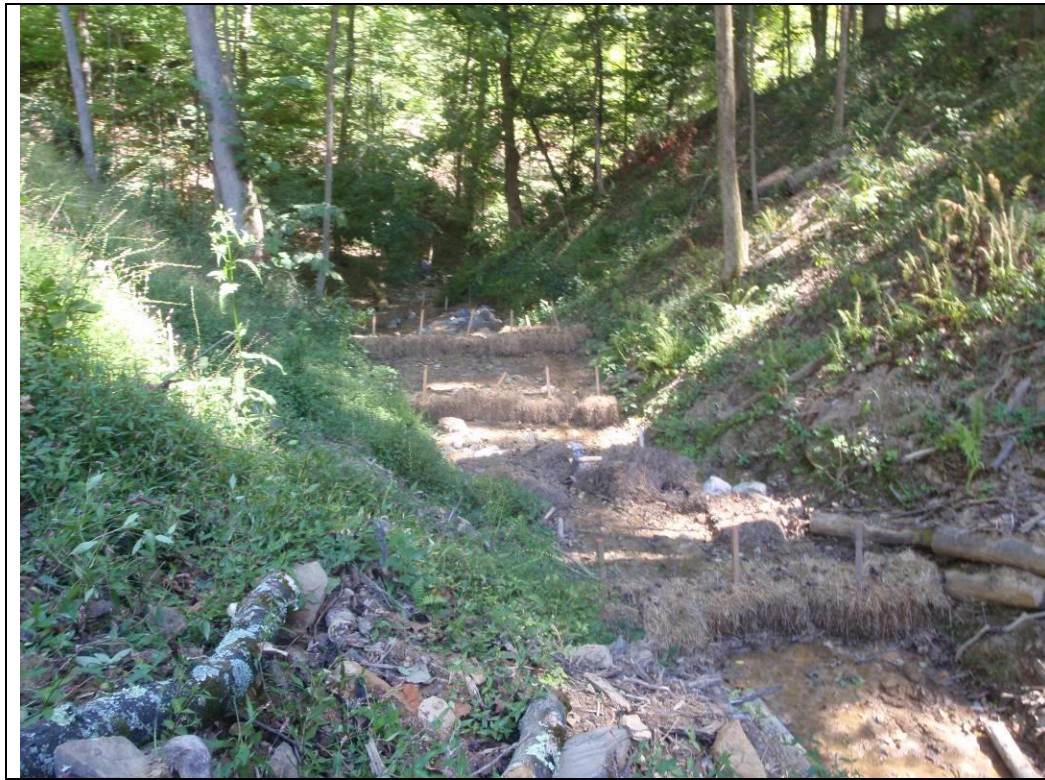
P9080206.JPG

Stream Channel;
Photo taken near
toe of the fill

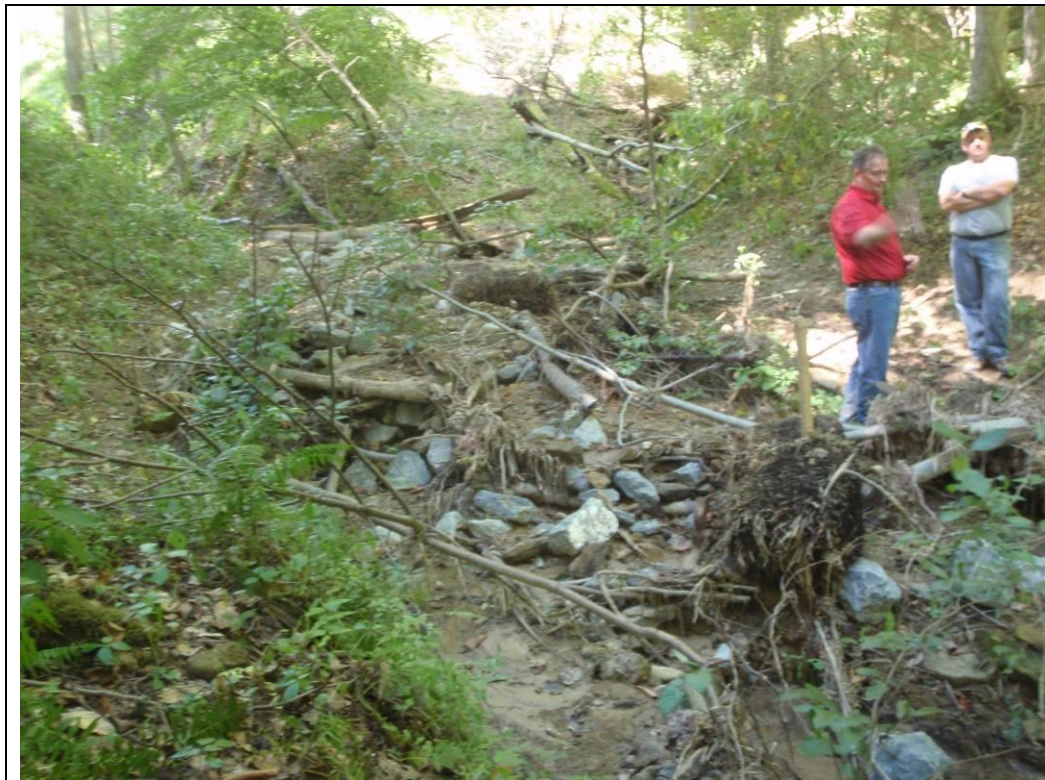
P9080207.JPG

Debris in stream
channel

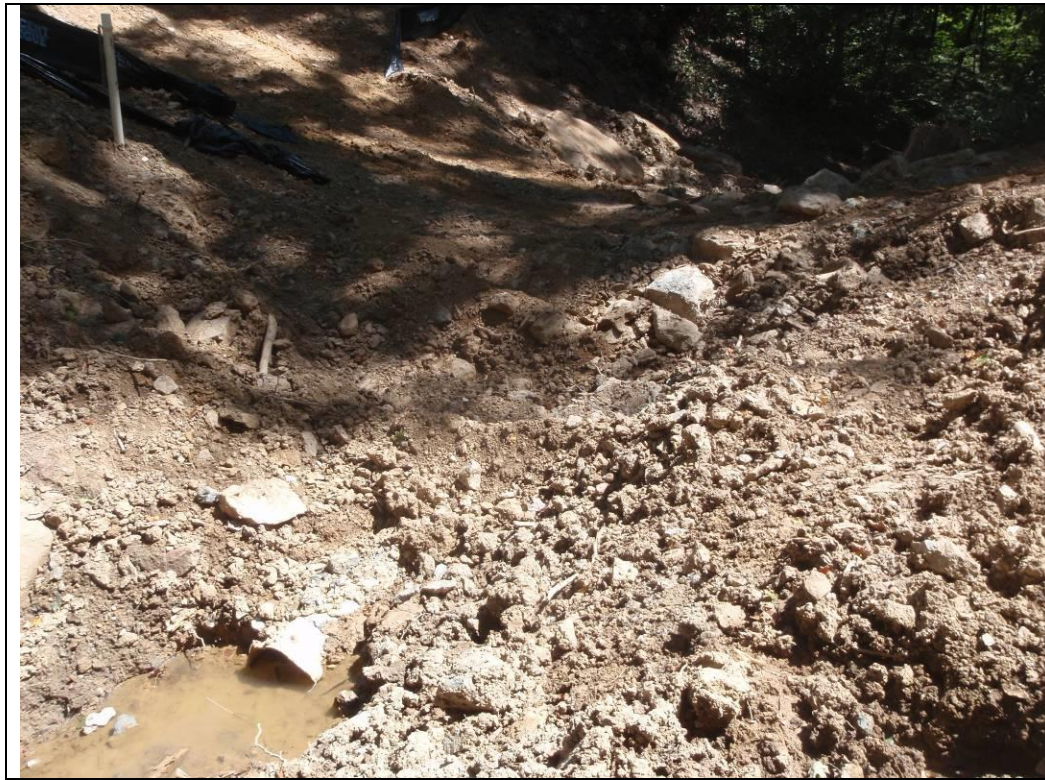
P9080208.JPG

Stream/culvert fill (~40 lf) discovered during inspection. Culvert visible in lower left-hand corner of photo

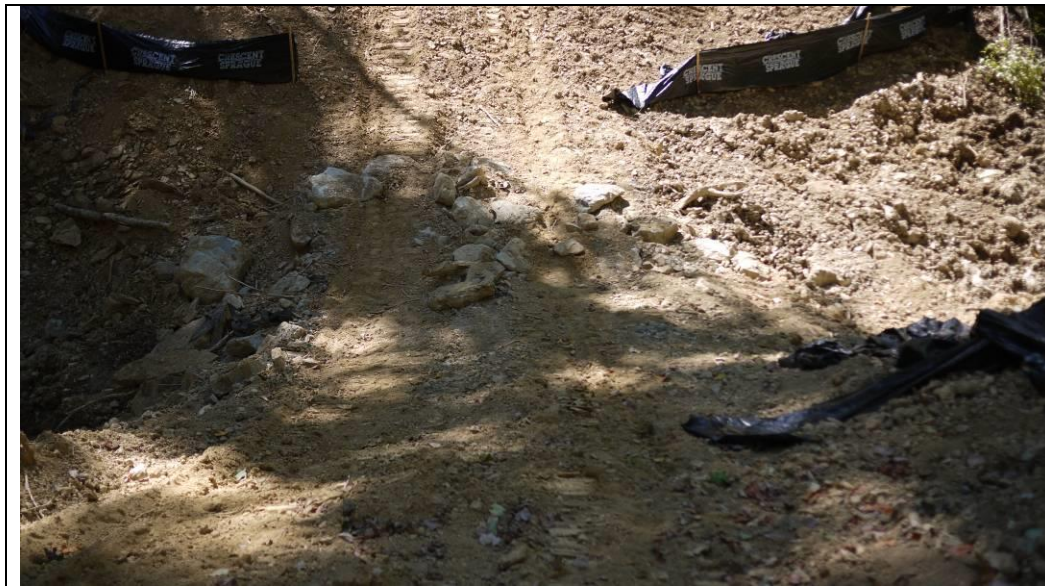
P1030238.JPG

Stream/culvert fill (~40 lf) discovered during inspection

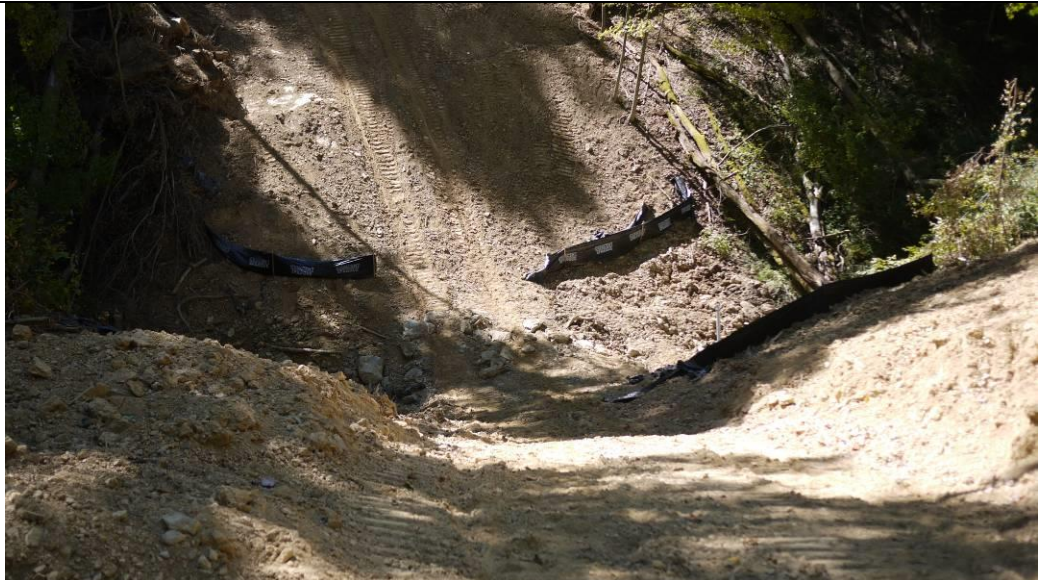
Photo ID: P1030240.JPG
	Date: 9/8/2010
	Description: Stream/culvert fill (~40 lf) discovered during inspection; View from above

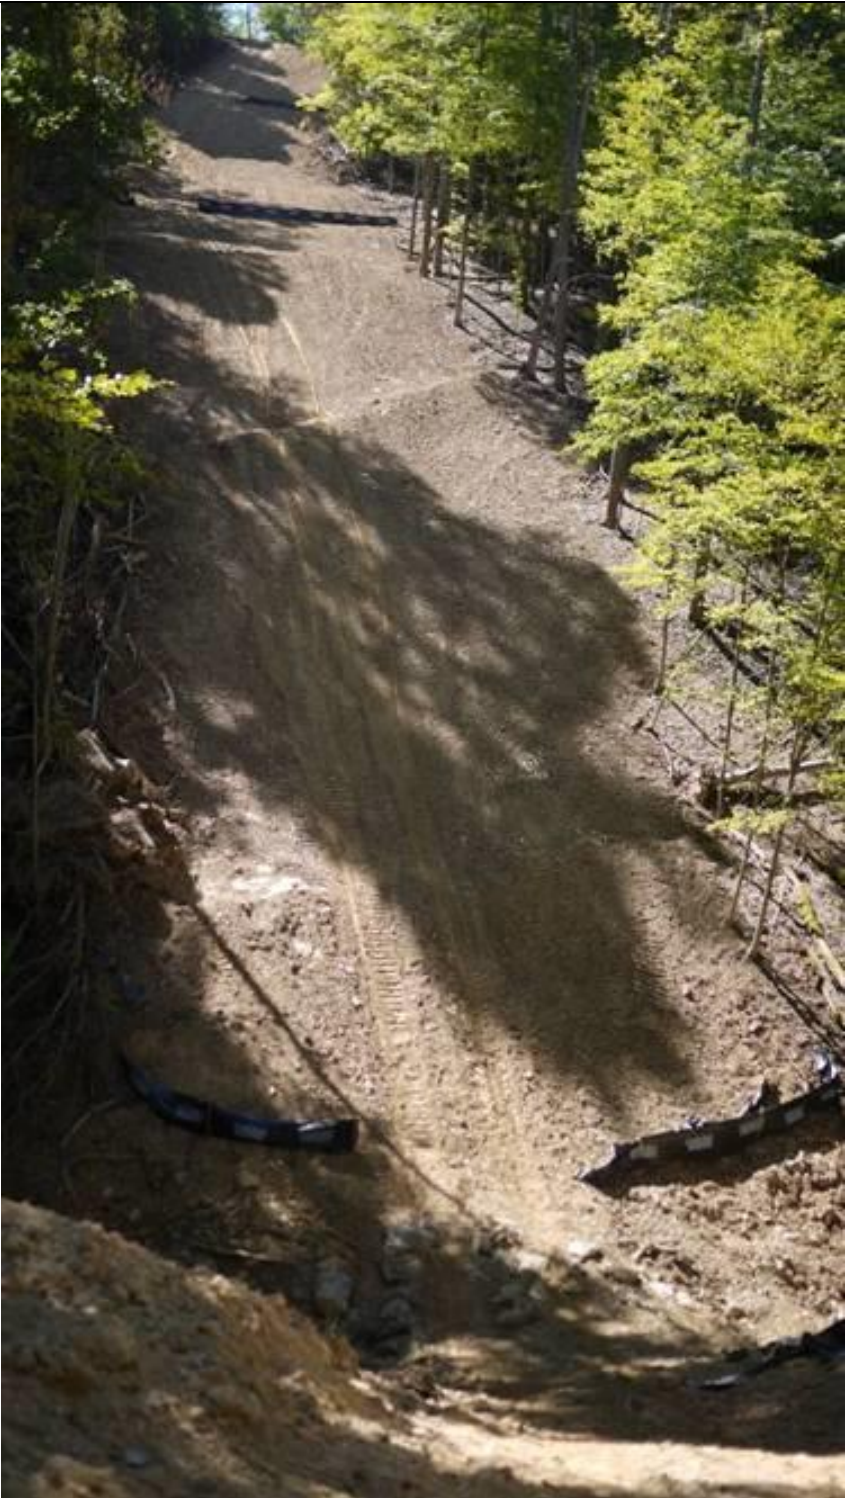
Photo ID: P1030239.JPG
	Date: 9/8/2010
	Description: View of stream fill from above
